Manhole Inspection Summary

Manhole # S37EE_036MH

Insp Date: **3/23/07 11:53 AM**

Location Address: **439 PRESTON ST**

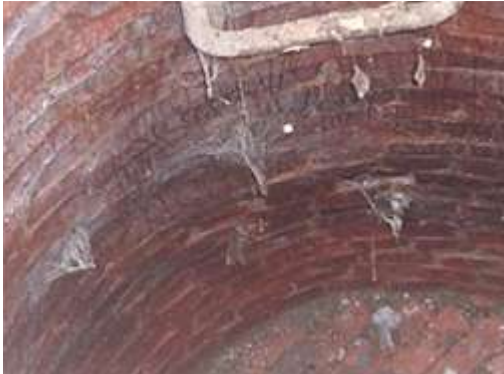
Defect

Bench ☒ Exists Material: **Brick** ☐ Parged ☒ **Debris** (not Condition related)

Bench debris.

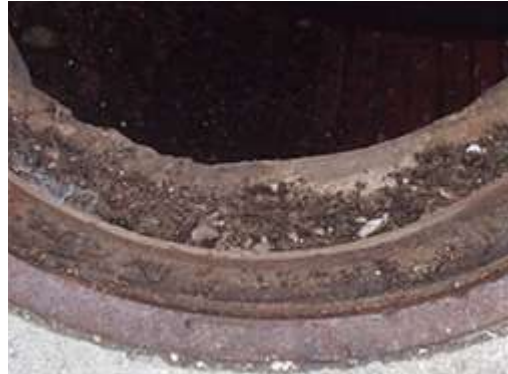
Defect

Infiltration: ☐ None ☐ Joint ☐ Cracks ☒ **Mortar** ☐ Roots ☒ **Wall**

Steps Count: **3** Missing: **2** ☐ Corroded

Barrel infiltration. Missing steps.

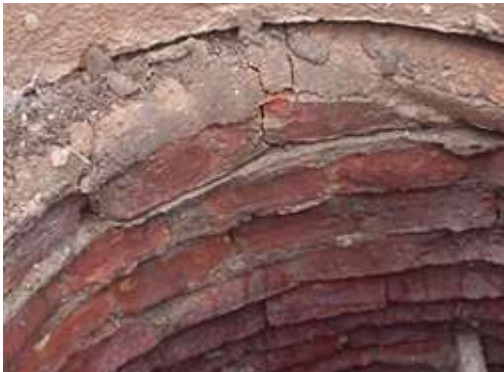
Defect

Frame Offset: **2** (in.) Condition: ☐ Sound ☐ Cracked ☒ **Leaks**

Condition: ☐ Sound ☐ Cracked ☐ Root Intrusion ☐ Loose Brick ☒ **Deteriorated**

Infiltration: ☐ None ☒ **Joint** ☐ Cracks ☒ **Mortar** ☐ Roots ☐ Wall

Frame offset. Frame leaks. Adjustment deterioration and infiltration.

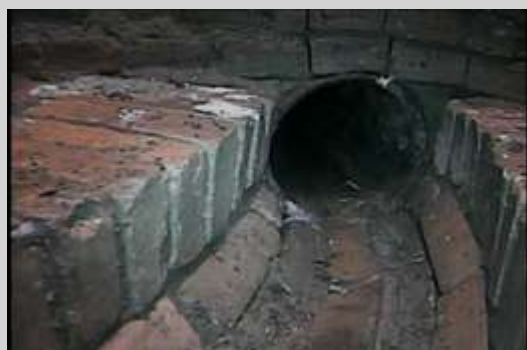
Pipe Out @ 12 O'Clock

Condition: ☐ Sound ☐ Cracked ☐ Root Intrusion ☒ **Deteriorated** ☐ Leaks ☐ Debris

Channel deterioration.

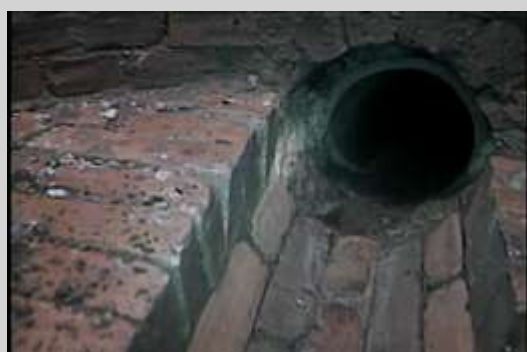
Pipe In @ 8 O'Clock

Bench deterioration.

Infiltration: **Evidence** Pipe Seal Cond: **Broken**
